**REPORT OF THE TECHNICAL EVALUATION
OF THE
VIROQUA MUNICIPAL SWIMMING POOL
VIROQUA, WISCONSIN
February 7, 2014
(PRELIMINARY)**

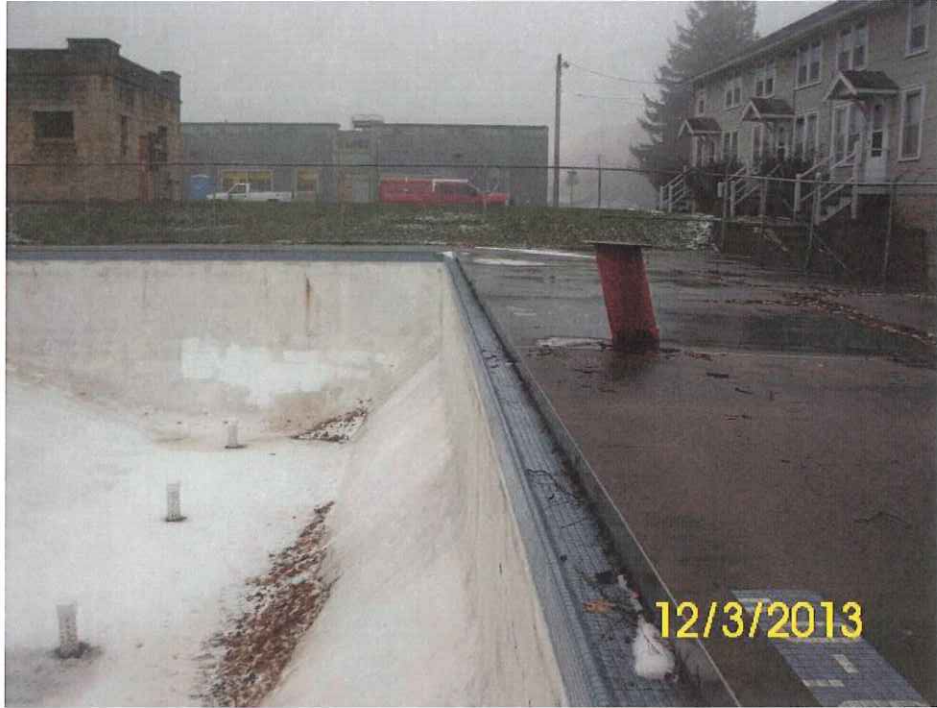
1. VGBA for outlets has not been addressed. Renovation of the four main drains is required;
2. ADA: The main pool perimeter length is greater than 300', requiring two ADA egress points. The pool is not compliant. Adding a lift and modifying the staircase for compliance is one option for repair;

Main Drains and Diving Tower Column

2. Diving activities are typically the highest liability exposure for a municipal swimming pool; therefore, BAI recommends that no diving towers be reinstalled during a renovation project;

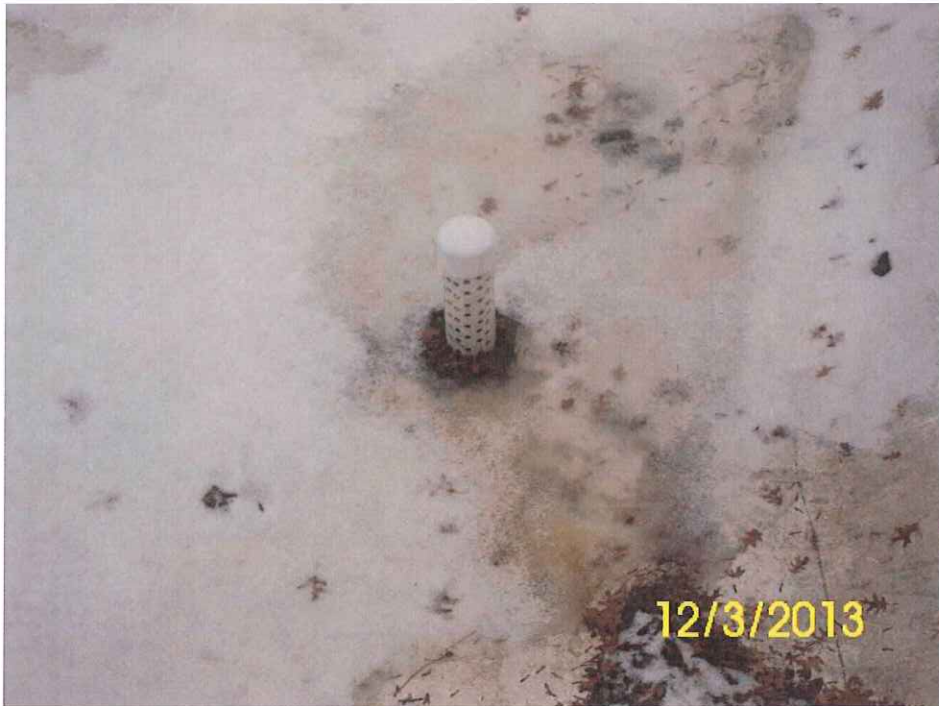
Main Drain

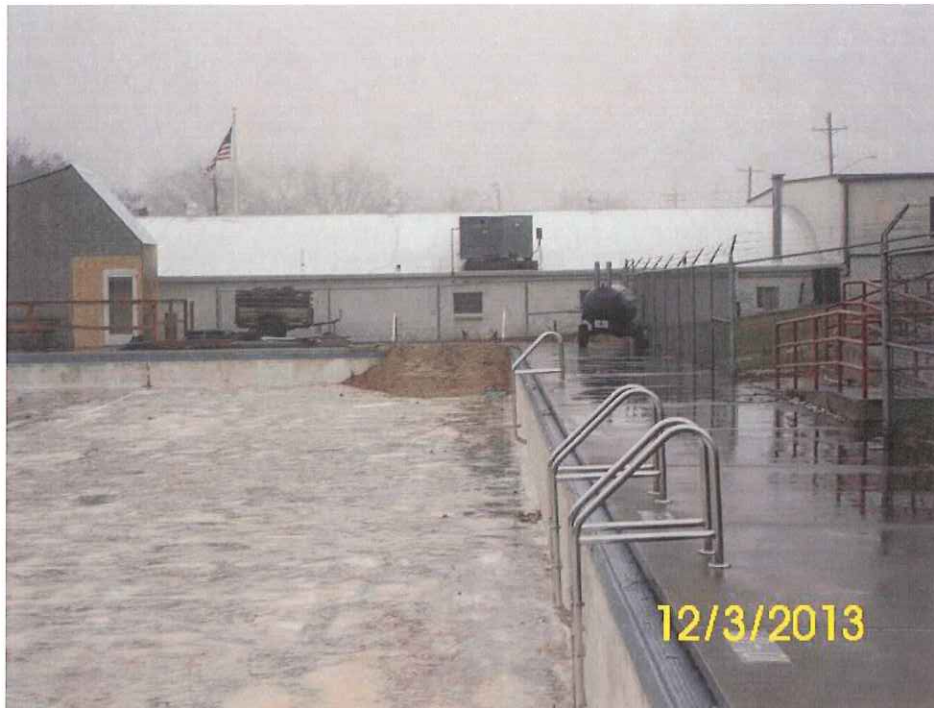
Shallow Area - Staircase filled in with Aggregate

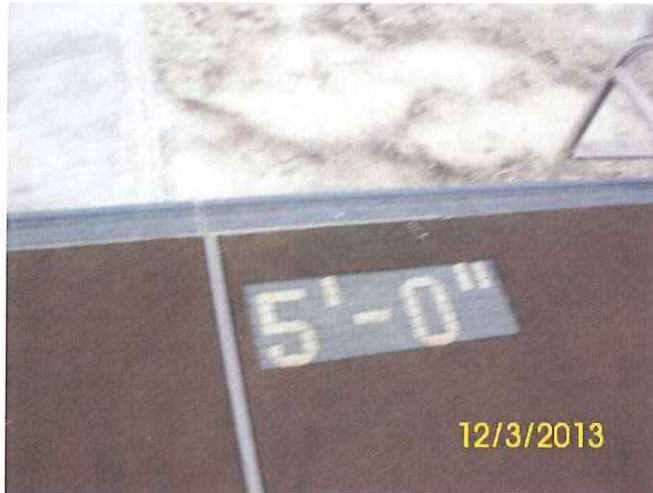
4. The depth markings are also required on the pool walls, no markings were observed on the walls and therefore additional markings would be required for Code-compliance;

Depth Markings

1. Complete replacement of the plaster finish is required;
2. The depth and no diving markings are in acceptable condition, however repair of the deck will likely require replacement, along with the addition to depth markings and universal no

diving symbols;

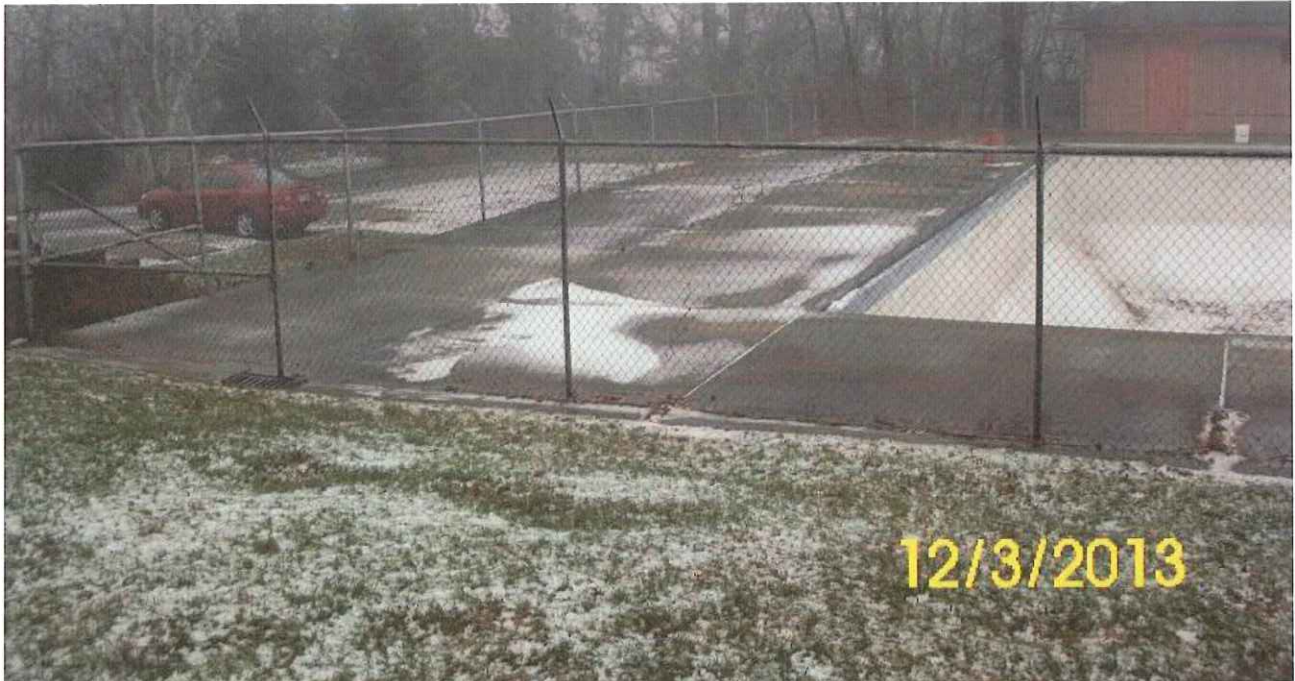
- The existing galvanized chain link fence is in fair condition;
- Barb wire is located at top of the fence, which is not inviting for a public use facility.

Chain Link Fence

- The overall condition of the fence is fair and does not need replacement at this time;
- Emergency exit gates should be added during a renovation project for Code compliance;

- 3. BAI recommends removal of barb wire from the top of the fence;
- 4. An 8' tall vinyl coated chain link fence with safety woven top is recommended, but not required;
- 5. Installing emergency exit gates, removal of barb wire and miscellaneous repair is included in the Opinion of Probable Construction Costs.

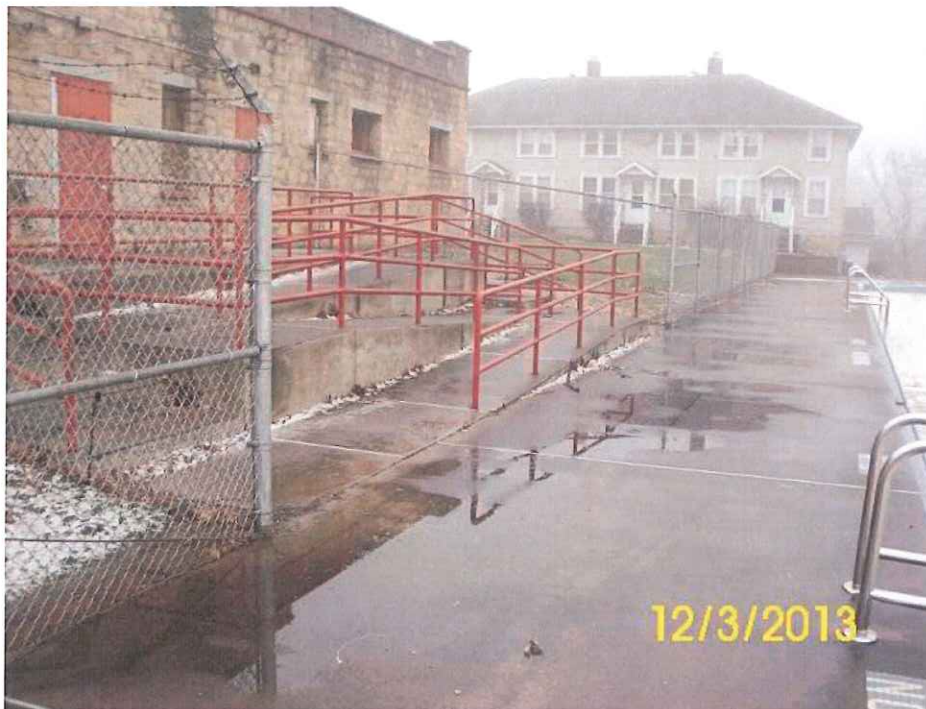
Ramp to bathhouse, note lack of deck drain

1. Deck drains are required between the pool and bathhouse;
2. Standing water observed by ADA ramp.

1. The deck must be sloped away from the pool unless drains are provided to intercept water on the way back to the pool. The deck must also be sloped to provide positive drainage of all deck areas. No drains are provided for the existing deck, standing water was observed between the pool and bathhouse, minimally deck drains are required between any building and the pool vessel.

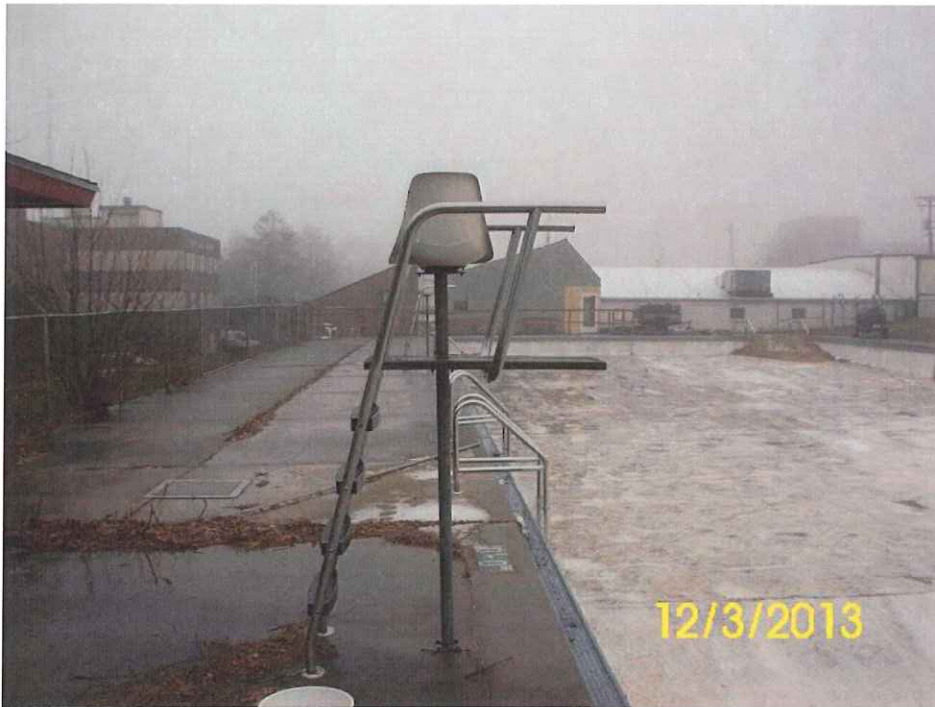
1. The existing concrete deck was installed as part of the 1982 project. The deck has sufficient expansion joints on the east and north sides of the pool. Based on condition of the existing deck, it appears that the south and west sides of the deck are original, while the east and north decks were replaced after the initial construction;
2. There is a wood fence constructed within 5' of the shallow end of the pool vessel;
3. The existing ramp from the bathhouse needs adjustment for the most recent ADA requirements;
4. Frost heave is substantial on the south and west sides of the deck. A large portion of the deck will need to be replaced prior to reopening.

1. Concrete deck elevation differential of 1/4" or more were observed in adjacent deck slabs,

resulting in tripping hazards;

Decking – West Side, Repair and Partial Replacement Required

1. During a pool renovation project a large portion of the deck would require replacement. A new pool will require completely new deck. Partial deck replacement is included in the Opinion of Probable Construction Costs.

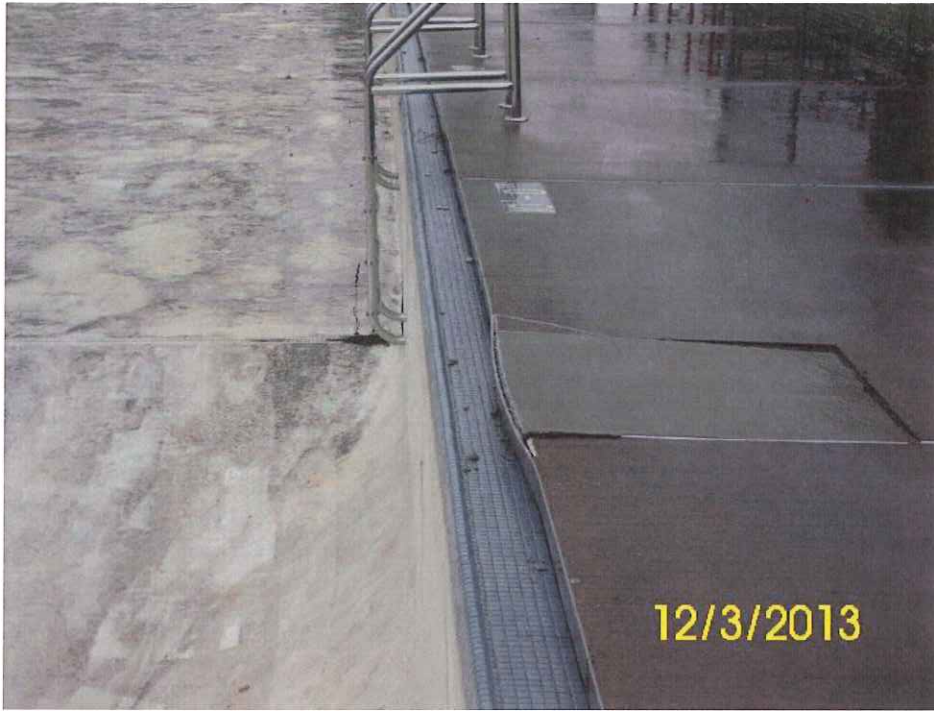
Deck – East Side, Partial Replacement Required

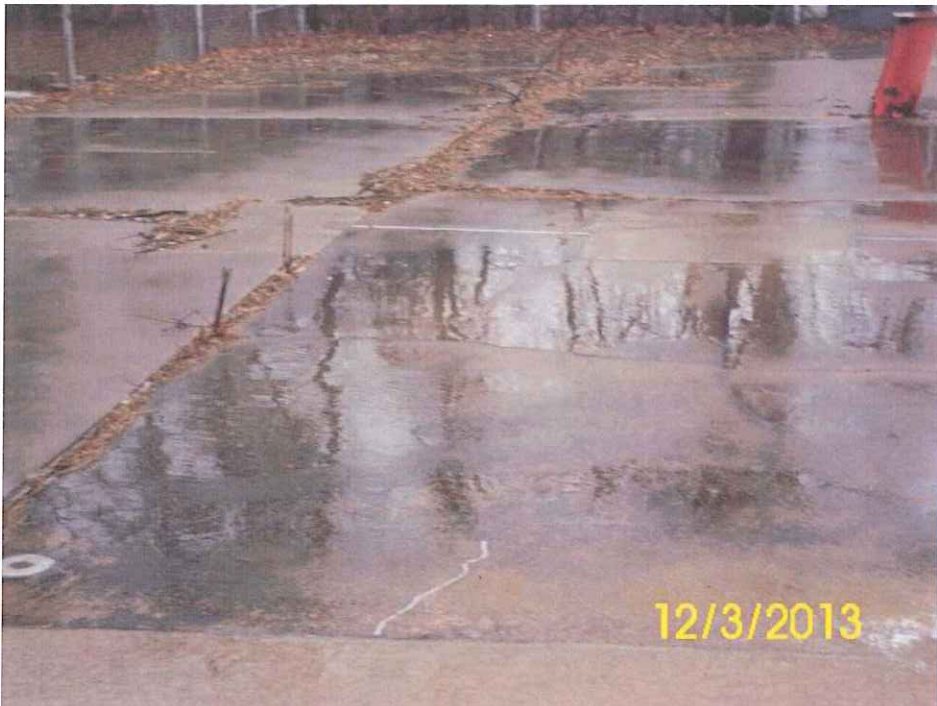
Deck – South Side, Complete Replacement Require

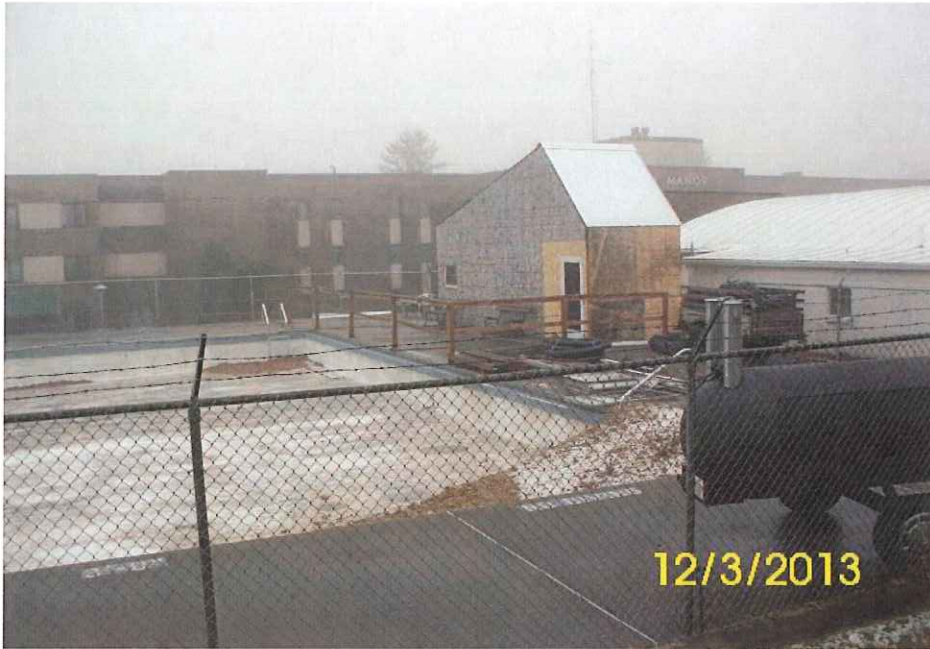
Deck – North Side, Partial to complete replacement required

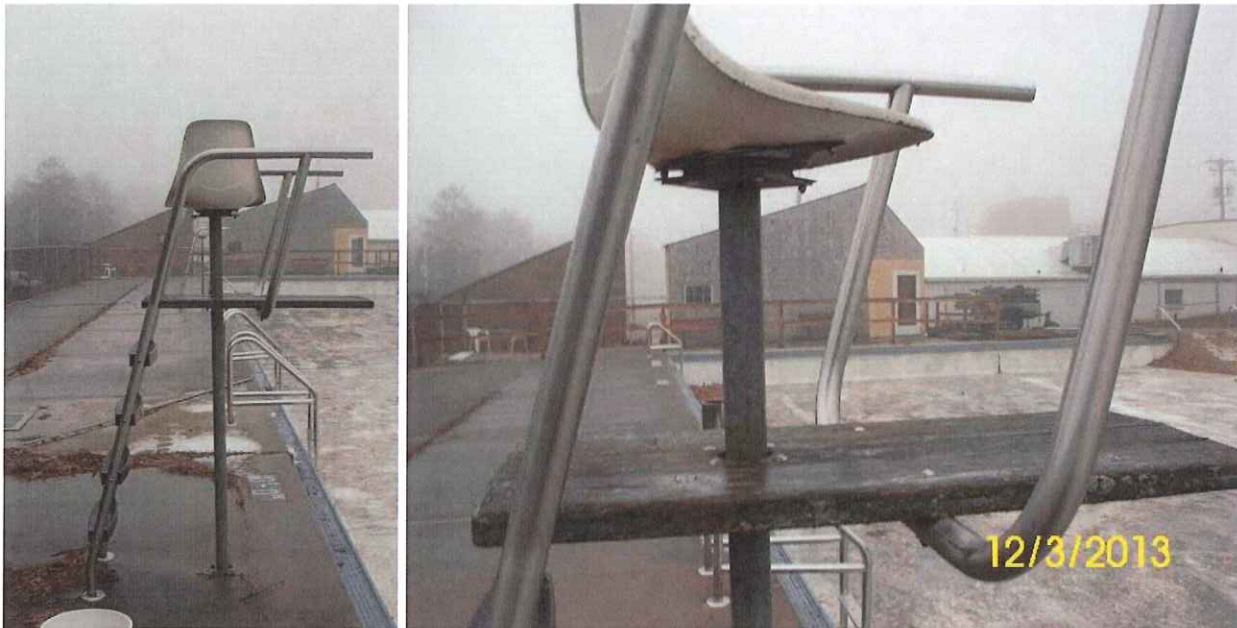
1. The existing ladders are in poor condition;
2. The lifeguard chairs are not OSHA compliant and appear to be from the 1982 project;
3. The diving tower has been removed with the only the steel pedestal remaining.

Lifeguard Chair

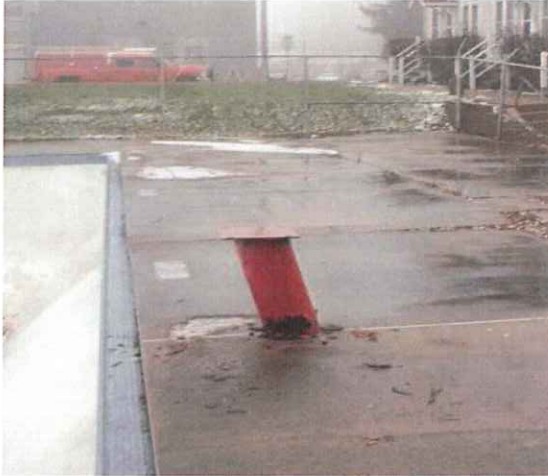
Diving Tower Removed Pedestal Remains

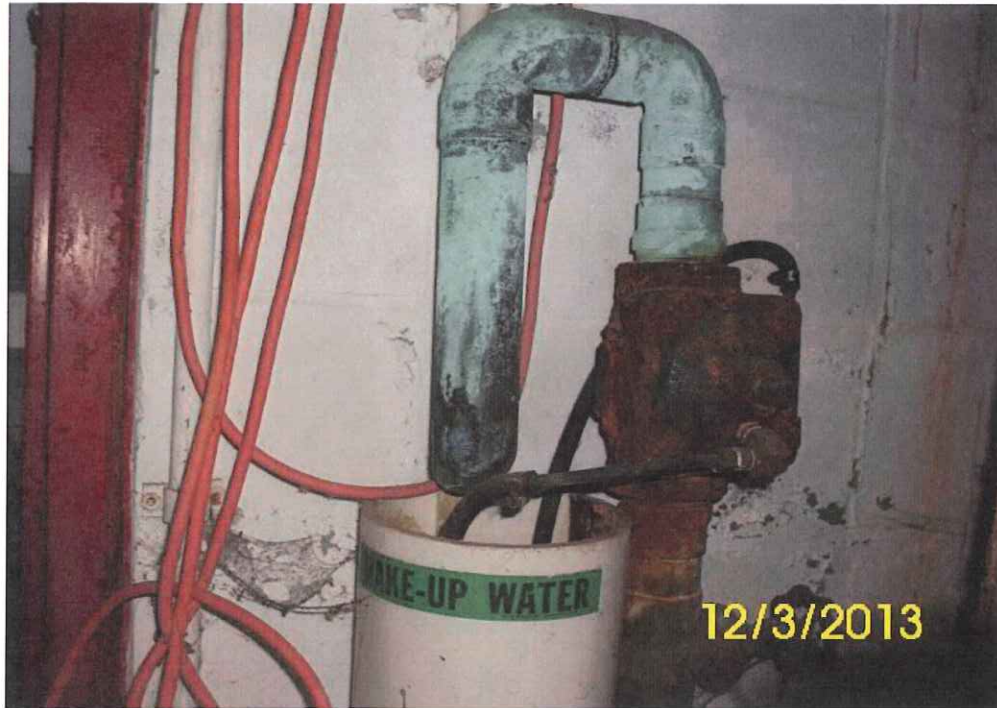
- 1. The existing pool drains to the street west of the pool;
- 2. The fill line does not have a 6" air gap; however, the line can be adjusted to achieve a 6" air gap. The valve for the auto-fill is deteriorated and likely does not work as designed.

Auto-Fill

1. Repair of the auto-fill valve and modification for the surge tank reuse is included in the Opinion of Probable Construction Costs.

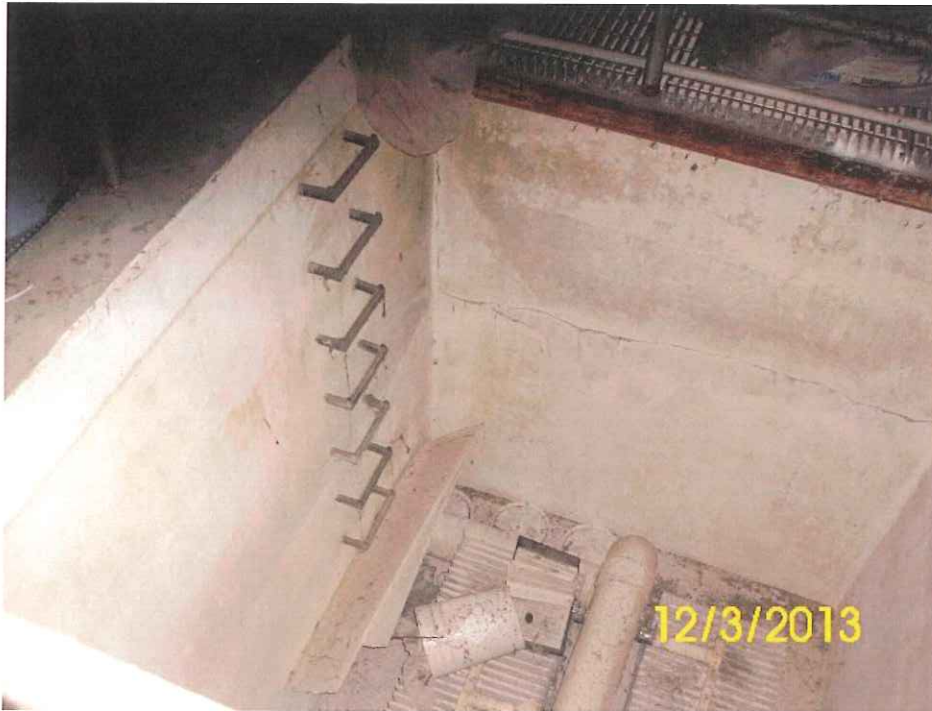
1. The existing filter is a site built DE filter with 832 gpm capacity. This style filter is effective at filtering water, but is difficult to maintain and operate. BAI recommends replacing the existing filter with high pressure sand filters;
2. BAI did not enter the pit to review the septum; the filter would most likely be operational after a thorough cleaning and restoring the DE to the septum.

1. The existing filter is sufficiently sized, which is based on BAI's estimation of the existing filter area and existing pool recirculation rate;
2. The existing filter is not NSF listed. Filters are required to be NSF listed. A renovation project would require filter removal and replacement with NSF listed models.

DE filter

1. BAI recommends replacing the existing filter with a high pressure sand filter, which will lower operational costs;
2. The filter cleaning and repair is included in the Opinion of Probable Construction Costs.

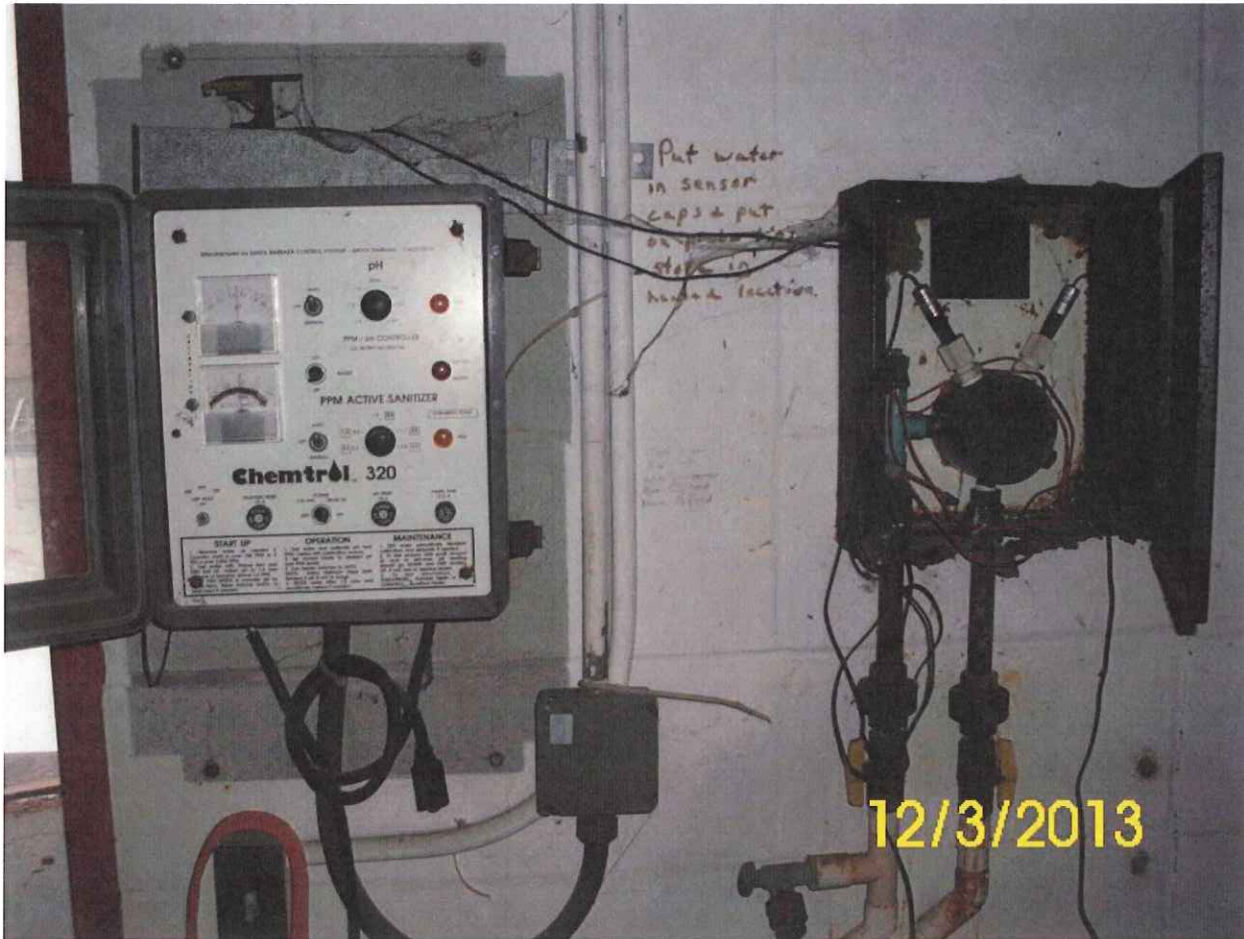
1. The existing chemical controller is the original 1982 technology. While the unit may still be operational it would be best to replace the controller with a newer model;
2. The existing sampling stream needs to be replaced, the probes are not functioning and the system is in poor condition.

Chemical controller and sampling stream

1. A new controller is included in the Opinion of Probable Construction Costs.
The City can discuss lease opportunities with the local chemical which could reduce yearly

maintenance costs on the system.

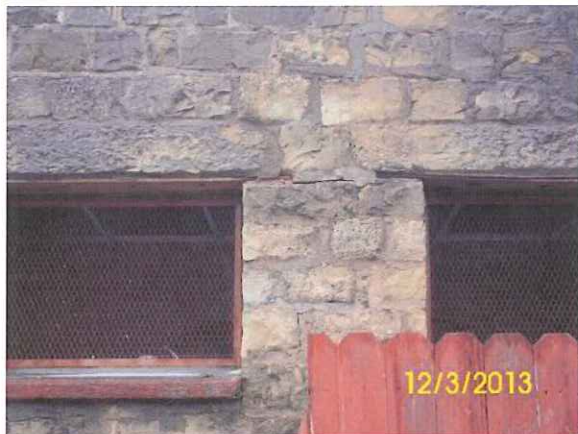
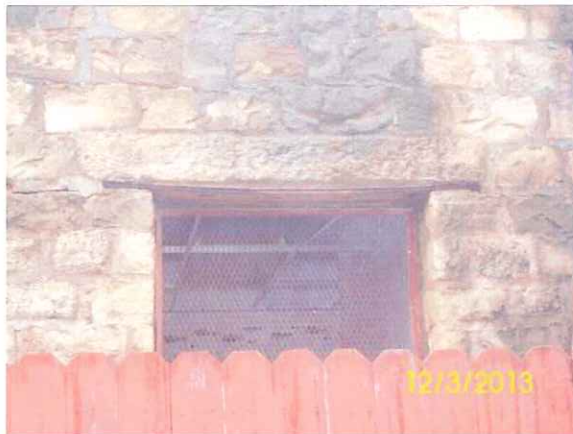
1. Several steel lintels are badly corroded and are in poor condition;
2. Interior archways are badly broken, however the archways do not appear to be structural and could be removed;
3. Interior walls are a combination of masonry or cast concrete. The masonry was likely added during the 1982 renovation project.

Lintels – Replacement required, bowed, rusted, unsafe

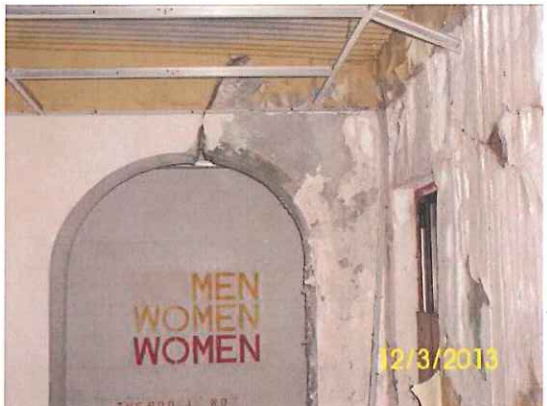
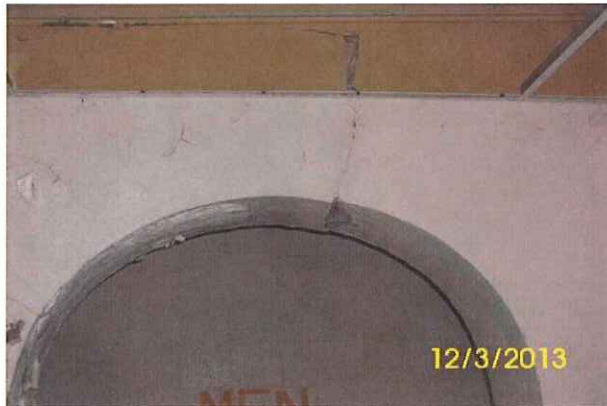
2. The majority of the concrete walls are in good condition; however there are several walls that have severe cracking. The archways in the entrance of the building are in poor condition and need to be replaced;
3. The coatings of the walls, floors and ceilings are in poor condition and in need of repair.

Bathhouse – Archways with full depth crack

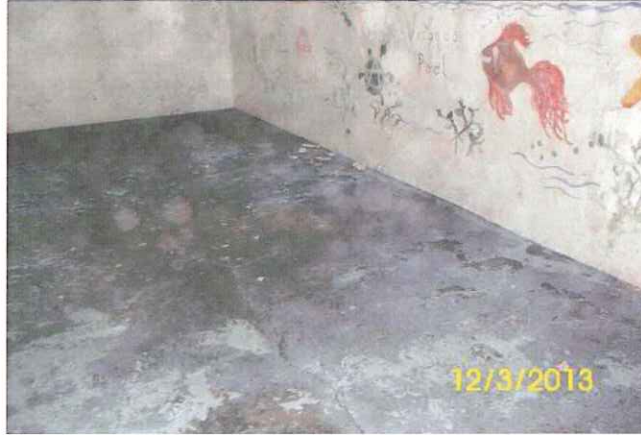
Bathroom – Floor and wall

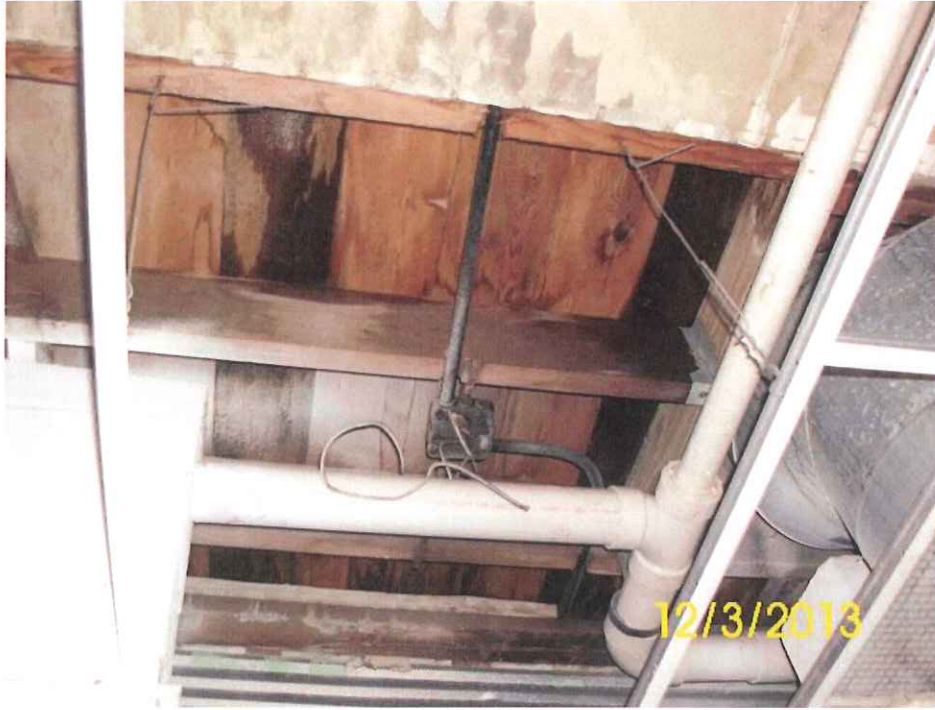
1. The existing roof is a flat roof; BAI did not observe the roof from the top side;
2. The existing roof leaks in multiple locations. The water from the leaks is damaging the roof structure;
3. Multiple rafters are rotting and in poor condition.

Wood Rafter Structure – Wet and rotting

1. Removal and replacement of the entire roof system is recommended and is included in the Opinion of Probable Construction Costs for this line item.

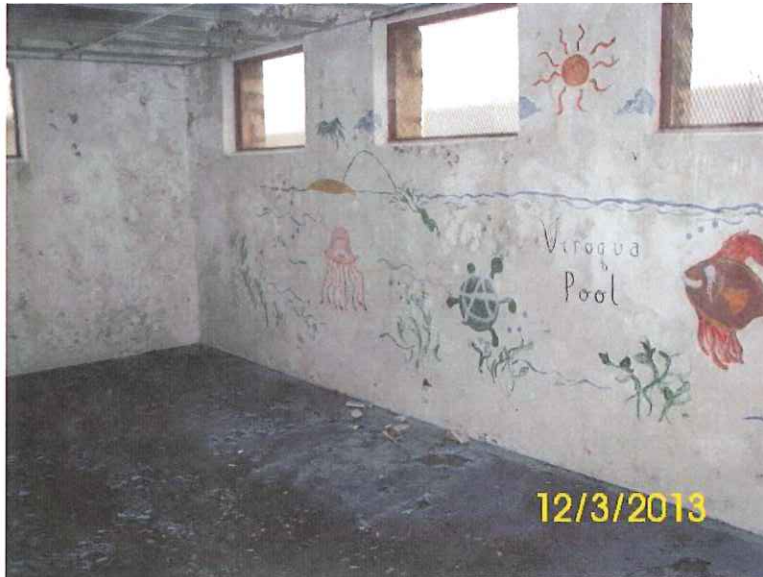
1. Windows in the restrooms are expanded steel;
2. All windows and doors are in fair to poor condition and are in need of replacement.

Expanded metal Windows

1. Replacement of the door frames, doors, and hardware is recommended during a building renovation project and is included in the Opinion of Probable Construction Costs.

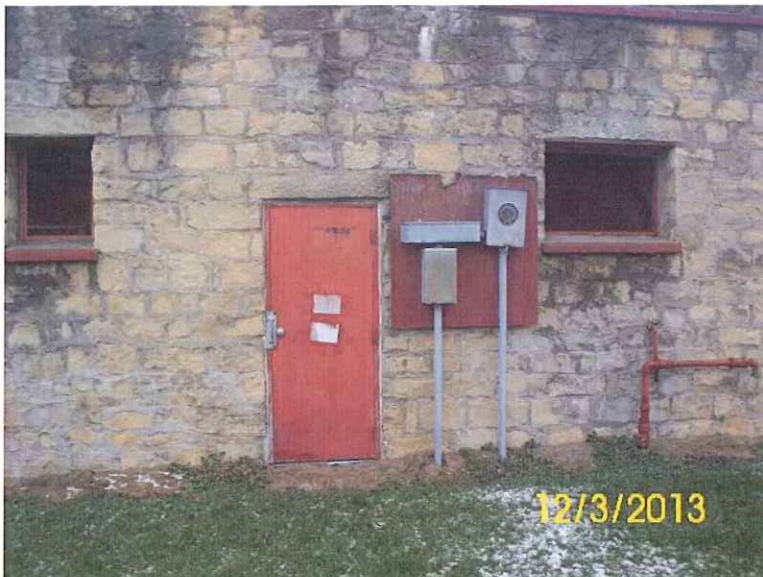
Bathroom Doors – Poor condition, Hardware not ADA

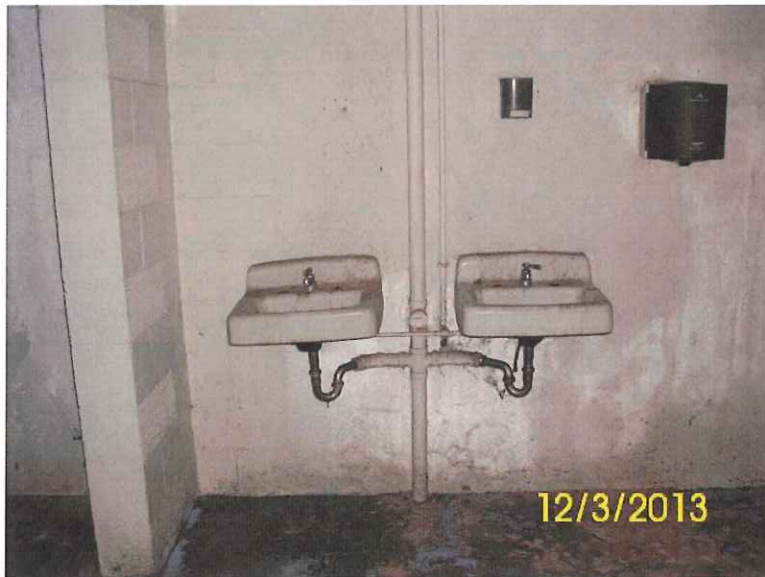
Existing Lavatories

1. ADA requirements have not been addressed. Sink faucets, drinking fountain, and showers are not ADA-compliant;
2. Individual shower drains are required in the plumbing Code;
3. By reviewing table 390.19 of the Wisconsin Administrative Code, we determine the number of fixtures required. The existing pool fits into the range of 9,000 to 9,999 of cumulative area of water surface. The required number of fixtures is located on the table above. The present bathhouse has a deficiency of 6 female water closets, 1 male urinal, 2 female lavatories, 1 male lavatory, 3 female showers and 3 male showers. The only fixture with the correct number of fixtures is the male water closet.

1. BAI recommends that the entire bathhouse plumbing system be replaced and updated with the required number of fixtures, along with the correct number of ADA fixtures. Complete replacement is included in the Opinion of Probable Construction Costs.

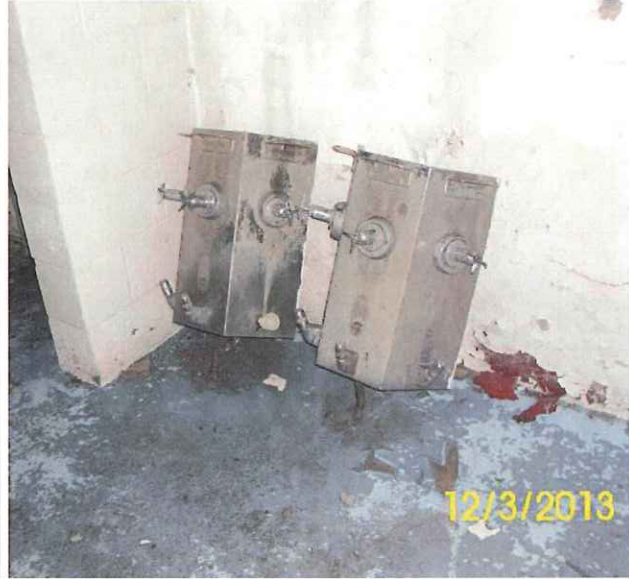
Existing Dismantled Showers
